From: Danny Flannery
Sent: Monday, April 20, 2009 9:48 AM
To: Christy Woodward
Subject: silt fence @ Pandora and Snowball

Erosion Control at base of waste rock for Pandora and Snowball Mines.

Project completed on 04-17-2009

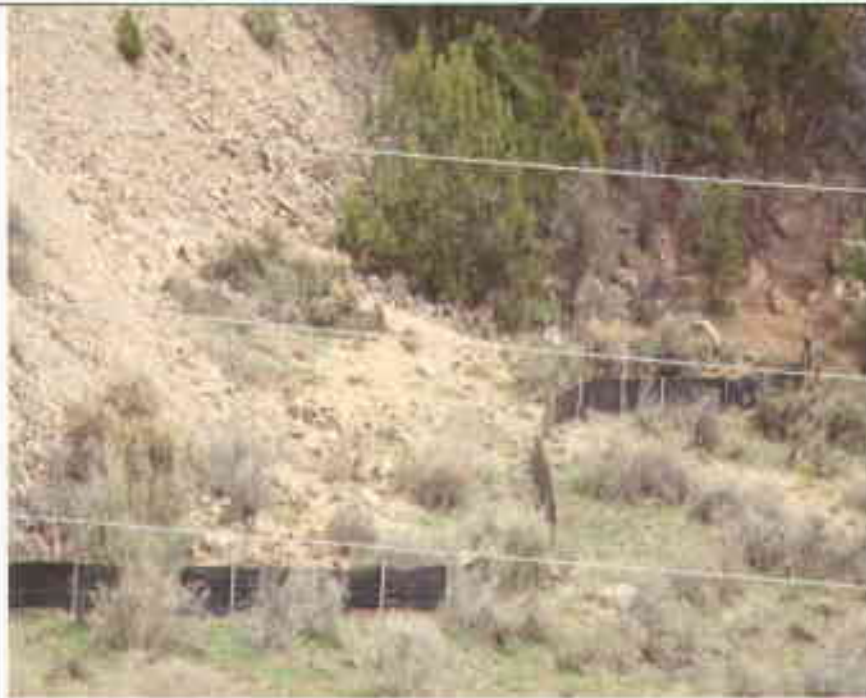
These pictures show the silt fence which has been installed at the base of the Pandora waste rock pile. The straw berm installed last summer was destroyed by cattle during the winter.

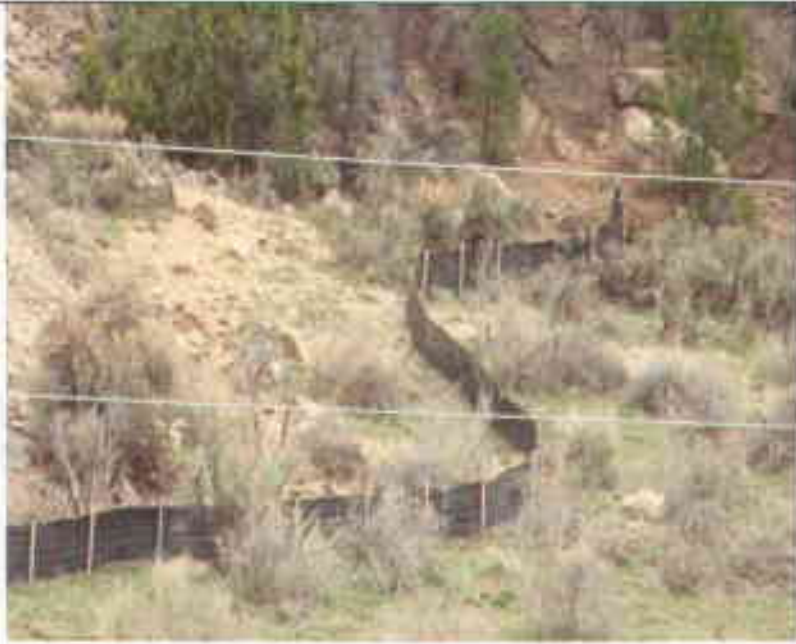
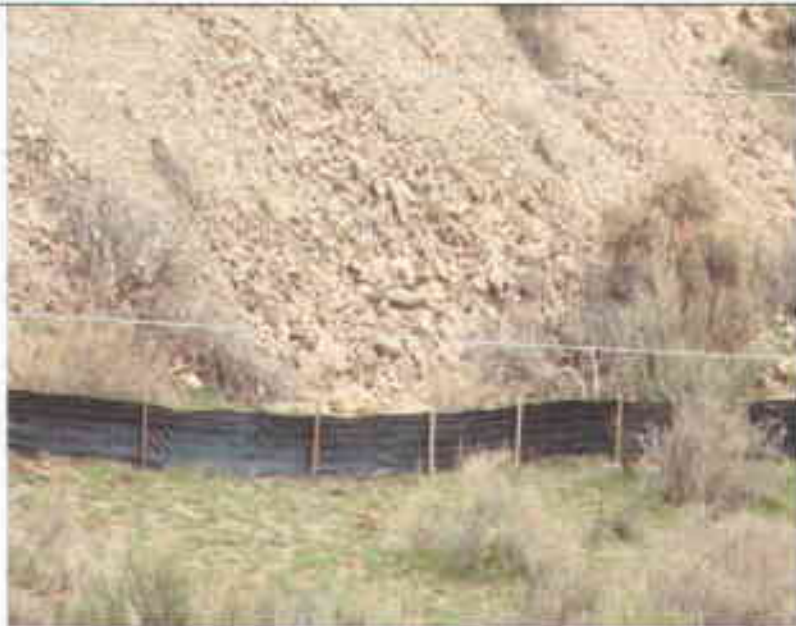
The fence is wire backed and buried into the ground.

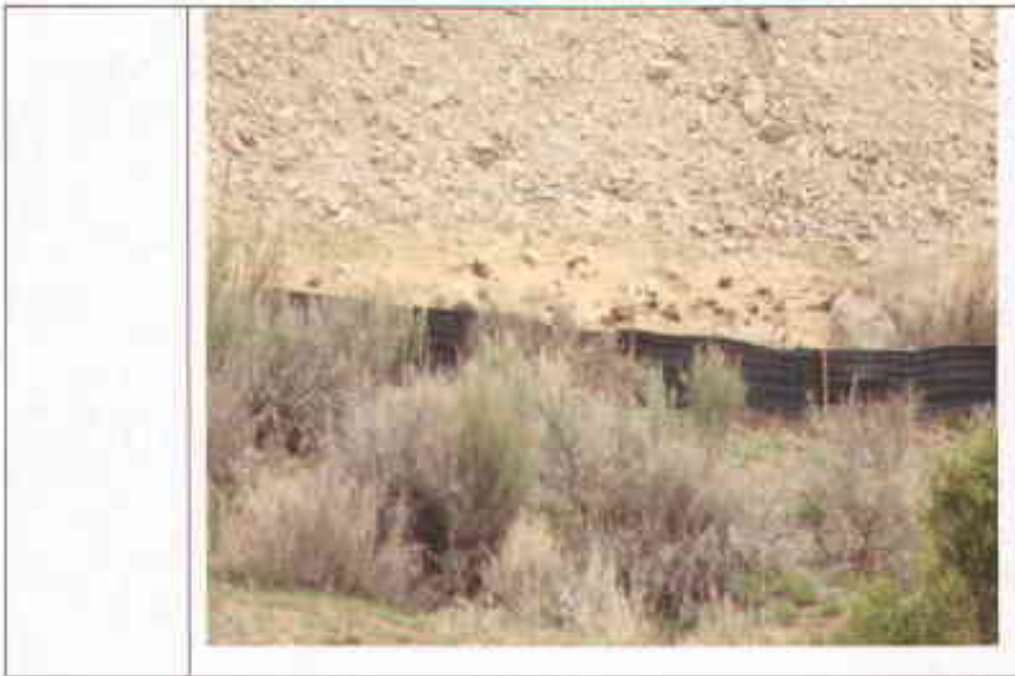
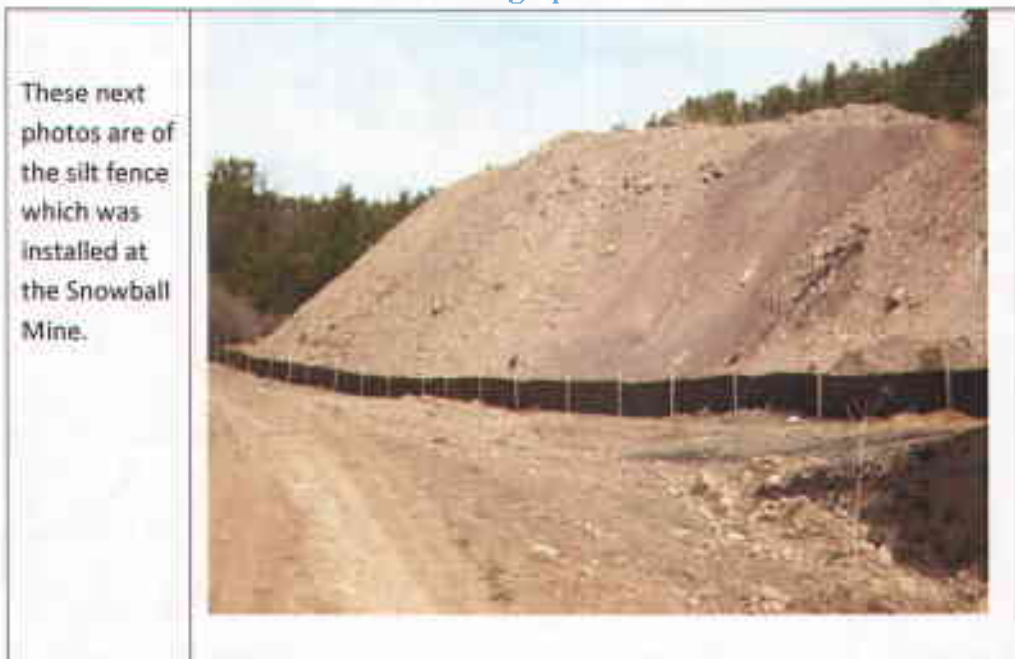
Waste rock storage pile at the Snowball Mine
